# Study on Engine Learning Experiencing Low Power On Cummins QSL 9.3L Engine

**Abstract:** The Cummins QSL 9.3L diesel engine is a production engine from CLG or Cummins Liugong. This type of engine is typically used in heavy equipment such as Wheel Loaders. A diesel engine is an internal combustion engine where the combustion process occurs inside the engine itself, and pure air is compressed within the combustion chamber, resulting in high air pressure. It operates in four strokes. This engine experienced low power, causing it to malfunction, which led to abnormal operation. Various checks were conducted, including inspection of diesel fuel, fuel tank inspection, engine oil level check, visual inspection of the air cleaner, water separator check, Fuel Feed Pump check, and Clearance Valve Lash check. The problem identified was the mismatch of Valve Lash clearance in the engine, resulting in low power. The repair step involved adjusting the Valve lash using a Feeler Gauge. The purpose of this research is to provide an explanation of troubleshooting and to perform repairs on engines experiencing low power.

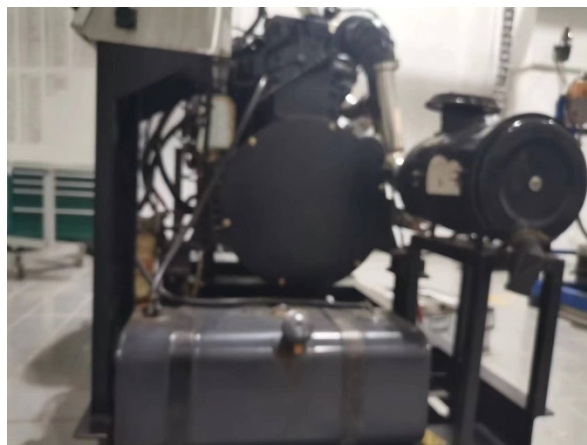
**Figure 1.** Fuel tank

As a fuel storage place, the fuel tank plays a crucial role in the fuel system. The visual inspection of the fuel tank did not reveal any leaks or fuel tank cap leakage, which could lead to fuel contamination, such as water contamination.

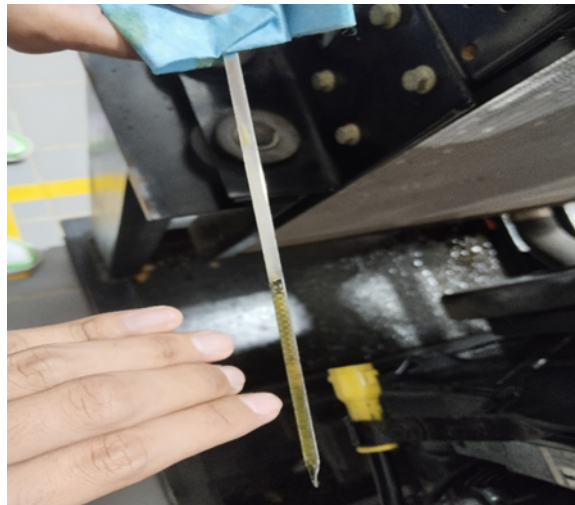
**Figure 2.** Oil Level

Checking the oil level of the QSL 9.3L diesel engine. The diesel oil level check showed no shortages, and the oil content appeared to be in good condition and suitable for use.

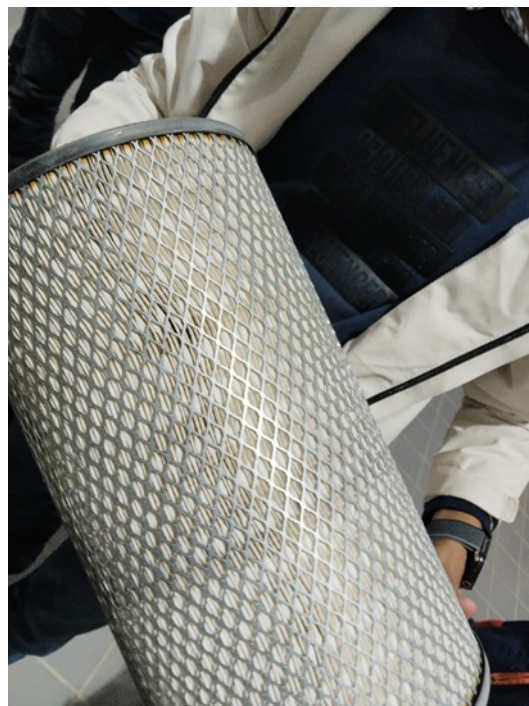
**Figure 3.** Air Filter

The visual inspection of the air filter element showed no dust or dirt buildup on the air filter, and after inspection, the air filter element was reinstalled into the engine.

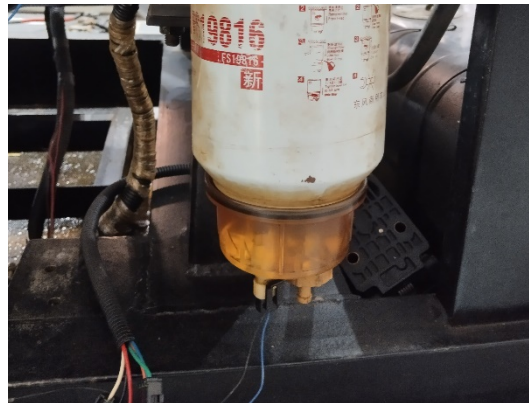
**Figure 4.** Water separator

Checking the water separator by draining the fuel mixed with water or contaminated with water by opening the drain plug on the water separator. This check revealed water in the water separator, and draining the water separator removed contaminants from the diesel fuel.

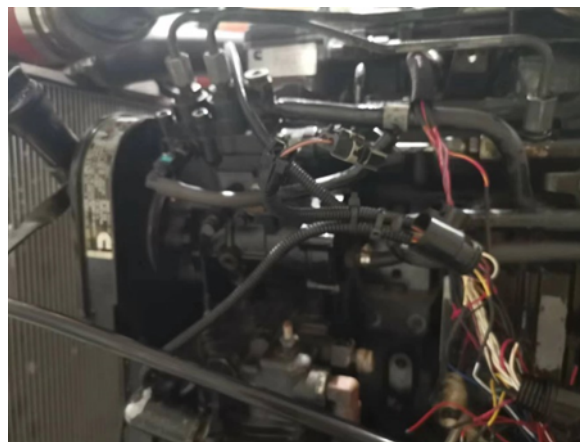
**Figure 5.** Fuel feed pump

Checking the fuel feed pump revealed no fuel pump leaks, and the pressure measurement on the fuel pump was normal. Fuel in the injection pump chamber must always be sufficient, requiring fuel to be delivered to the injection pump under pressure because the pump element cannot deliver enough fuel at high speeds. Therefore, the filling pressure is adjusted to 1.8 – 2.2 kg/cm<sup>2</sup> (25.6 – 3 psi) by the piston spring[14].

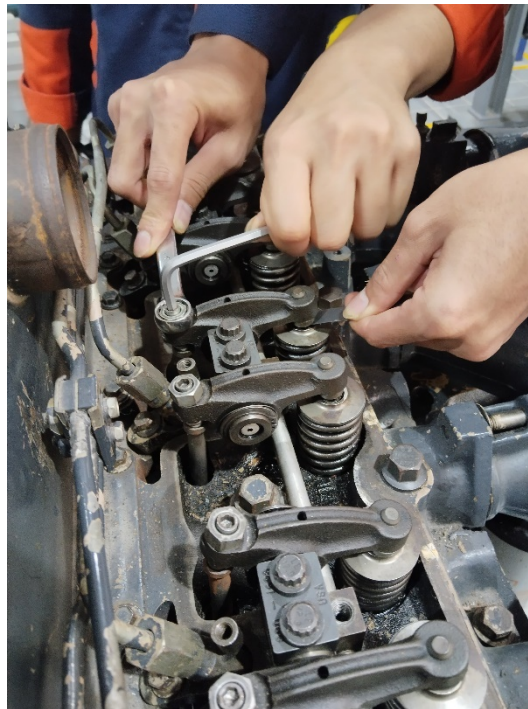
Figure 6. Valve Clearance

The next step after conducting all visual and specified tool inspections, from the easiest to the most difficult, was identifying the root cause of the engine experiencing low power, which was the mismatch of valve lash clearance on the Cummins QSL 9.3L engine, leading to decreased engine performance.

From the Top 1 inspection, it was found that the valve clearance did not comply with the specifications of the QSL 9.3L diesel engine, specifically for the intake cylinder 2 and the exhaust cylinder 3. This deviation from the standard valve lash is a potential cause of the engine experiencing low power.

From the table above, after measuring the valve lash, discrepancies were found in the standard valve lash for intake cylinders 5 and 6, and for exhaust cylinder 2 and 6. Therefore, based on this measurement, there is a potential cause for the QDL 9.3L engine to experience Low Power

The repair process involves readjusting the valve lash according to the specified reference, with the valve lash readjustment process performed in accordance with the working procedure. After completing all the inspection sequences, the issue of Low Power Engine due to non-compliant Valve clearance was identified. The steps for remeasuring are as follows:
