Design and Construction of Magnetic Support Construction Separator on Track V 33 BC-5 at Greenzone 2

Abstract: The process of shredding and sorting waste in the Pre Processing method is one of PT Solusi Bangun Indonesia's contributions in overcoming waste and pollution problems. The waste will be shredded into certain sizes and put into the cement kiln. The processing place is called a green zone. In this process, sometimes the material transport contains impurities in the form of metal and the like. This distribution has the potential to cause foreign material to be carried because there is no sorting of waste content. Belt conveyors and dynamic disc screens are often damaged by the metal material. This problem can be overcome with a magnetic separator to separate foreign metals from waste that is channeled using a belt conveyor. The magnetic separator provides protection for the dynamic disc screen and conveyor operating process from foreign material so that the potential for wear on the dynamic disc screen and torn belt conveyor can be avoided. The installation of the magnetic separator position uses a construction based on the optimal position. This study discusses the design

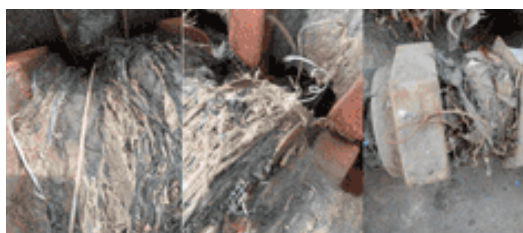
Figure 1. Dynamic disc screen is damaged

The result of this suboptimal metal separation causes some equipment to be damaged quickly, especially in the dynamic screen section. The dynamic disc screen will be quickly eroded by hard metal material that will rub against the disc screen. The price of a disc screen per set is Rp. 35,000,000.00 which will cost a lot of money if the disc screen is often damaged. Based on this background, a design and construction of a magnetic separator support is needed in the greenzone 2 area.
