Article

# Wire Rope Sling Failure Analysis: Technical Root Causes, Investigation Methodology Critique, and Lessons for Lifting Safety and Organizational Learning

Ahmad Zaky<sup>1,\*</sup>, Yudha Pratesa<sup>1</sup> and Johny Wahyuadi Mudaryoto<sup>1</sup>

<sup>1</sup> Department of Metallurgical and Materials Engineering, Faculty of Engineering, Universitas Indonesia, Depok, West Java 16424, Indonesia

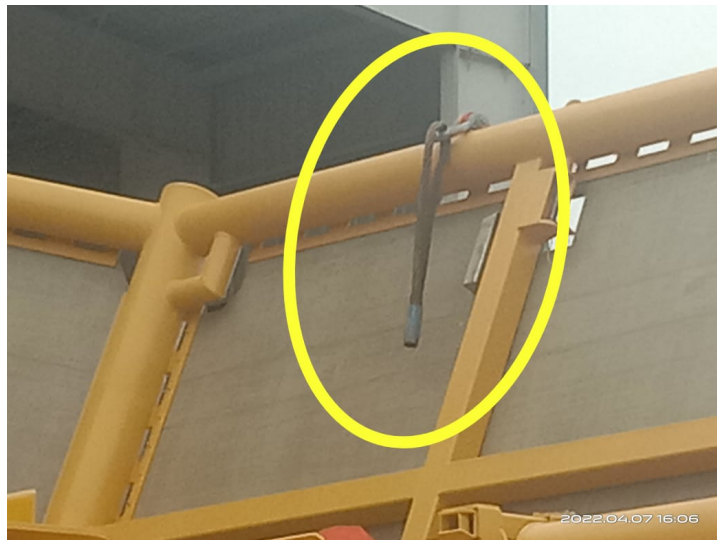
Figure 3 shows how one frayed end of wire rope sling remains attached to the panel's padeye, and Figure 4 shows the other end recoiled toward the crane hook. Fortunately, all personnel were well outside the exclusion zone, and there were no injuries when the sling snapped and the 19-ton panel dropped. The two broken pieces of sling remained attached at each end — one piece still on the crane's hook and the other still secured to the panel's padeye. The crew immediately stopped all operations and secured the area. Within minutes, they lowered the crane hook to the ground, detached the remaining sling piece, and used a man-lift to recover the sling piece that was still on the panel. The incident was formally reported, and an investigation team was mobilized to examine the failure. The chronological of event is explained in Table 2 in timeline order.

**Figure 3.** The wire rope sling parted near its end termination – one frayed end remains attached to the panel's padeye (yellow circled).

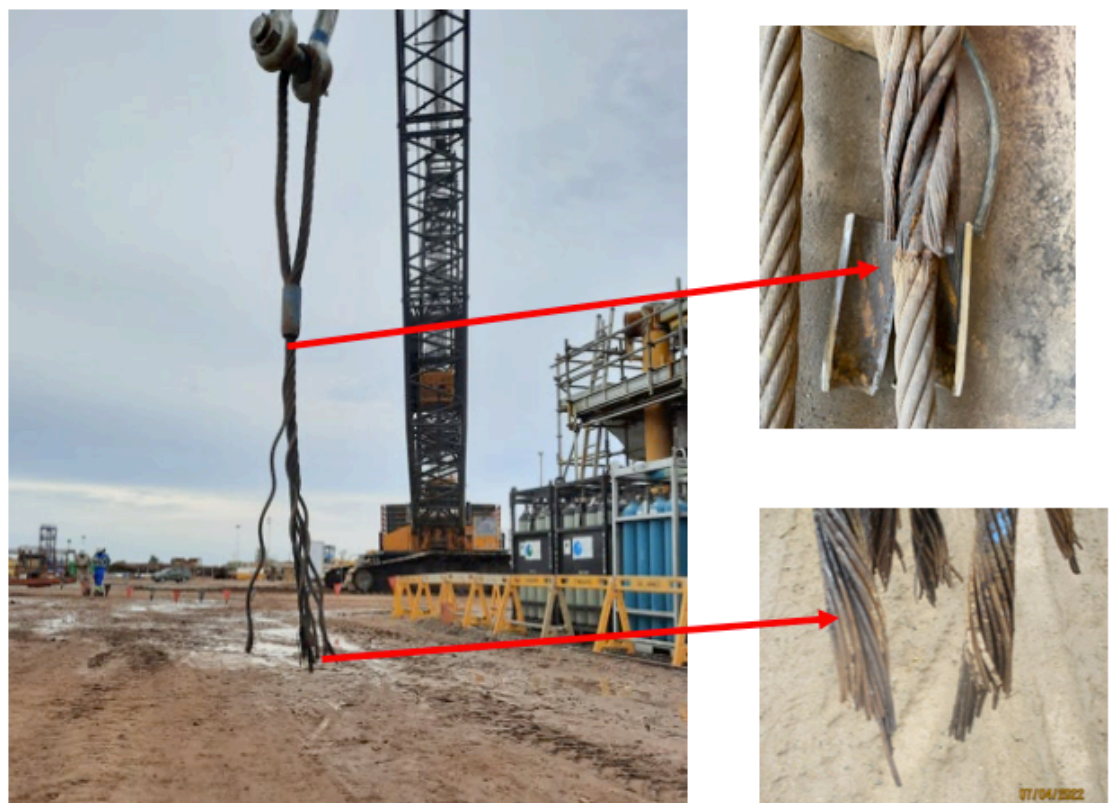
**Figure 4.** The other end recoiled toward the crane hook. The failure occurred at the sling's ferrule (socket) where the wire rope is swaged, later found to contain corroded wires.

Key Finding	Details
Sling failure due to hidden corrosion	The wire rope sling failed at its ferrule, where internal corrosion of the wires was found. This corrosion significantly weakened the sling, causing it to part under a load well below its original breaking strength.
Actual load far above design capacity	The force required to close the panel (~60 MT) vastly exceeded the panel padeye’s rating (8 MT) and the sling’s intended safe load. The single-crane method induced high friction and side loads, effectively resulting in a severe overload of the rigging.
Lift misclassified as standard	The operation was treated as a standard lift instead of a critical lift, contrary to procedure. A detailed lift plan and risk assessment were not carried out, and a planned two-crane method (from earlier testing experience) was not used.
Deficient risk mitigation	When warning signs appeared (load readings over limit, earlier attempts aborted), the team did not stop and comprehensively reassess the plan. The Stop-Work Authority was not utilized despite clear indications of danger (padeye and sling overload).

- **Failure Mode Identification:** The contractor's report indicates the sling "parted at the ferrule with signs of wire corrosion." This suggests a failure mode potentially involving corrosion-assisted breakage, but it remains unclear if the break was due to gradual fatigue or an instantaneous overload. Peer-reviewed investigations stress the importance of determining the failure mode via fractographic and metallurgical analysis [14][7]. For example, fatigue fractures initiated by decarburized micro-cracks in a failed crane rope, using microscopic examination [7]. In the contractor's case, no mention of detailed fracture surface examination or wire break morphology was made; thus, the precise failure mode was left somewhat ambiguous (the report lists "undetermined corrosion" as a factor). This is a partial gap – while the presence of corrosion was noted (a clue toward possible fatigue or stress corrosion cracking), a conclusive determination (e.g. overload versus fatigue failure) was not documented. Without techniques like scanning electron microscopy [2], the investigation may have missed distinguishing whether corrosion caused a brittle stress-corrosion failure at the ferrule or simply weakened the sling which then snapped in overload.

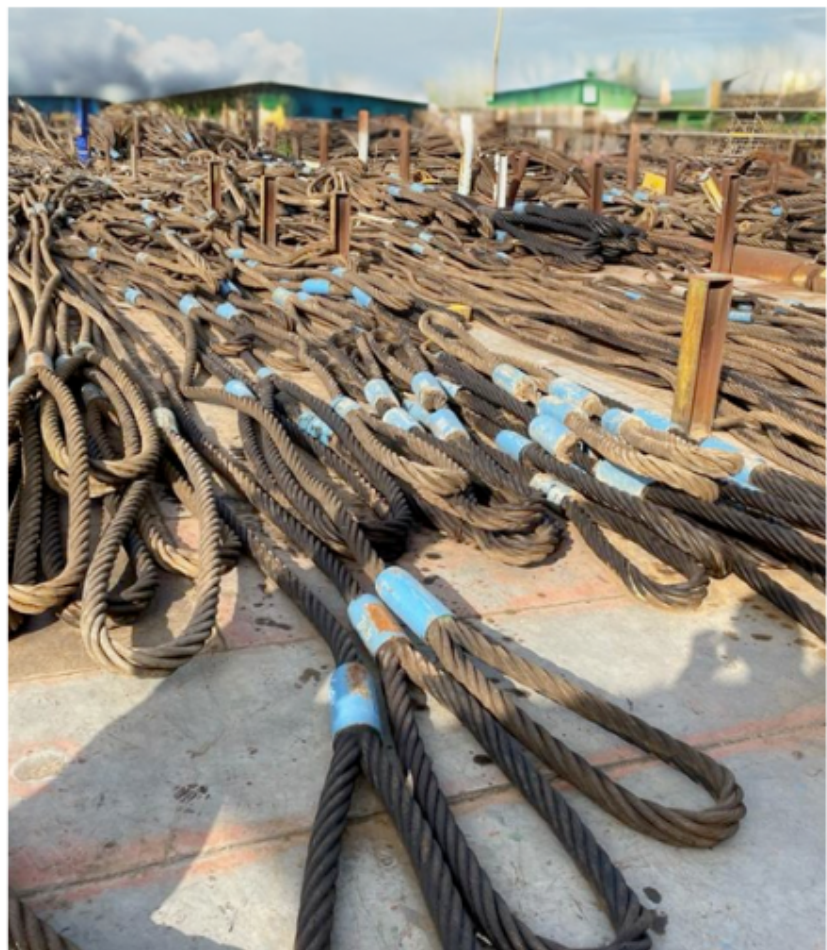
- Use of an aged sling without detecting internal damage: The failed sling had been maintained in the rigging inventory for many years. While it had proper certification documents and recent load test records, there was no age-based retirement criterion for slings in use – meaning an older sling could remain in service if it passed visual inspections and load tests. The investigation noted that the sling's storage conditions (often outdoors in a marine yard environment – see Figure 6) likely contributed to internal corrosion. The internal corrosion was not outwardly visible and was missed during inspections. This latent defect left the sling weaker than its rated capacity. When the sling experienced the high tension during the third trial, it failed below its original MBL, at the corroded section.

**Figure 6.** Sling outdoor storage condition

- **Enhance Sling Inspection and Maintenance:** Enforce a rigorous inspection program with daily pre-use checks by a competent person. Damaged slings, such as those with broken wires or corrosion, should be immediately removed from service. Following established discard criteria ensures worn slings are retired before failure.

- **Proactive Replacement of Aged or Damaged Slings:** Implement a policy to retire slings after a reasonable service life or harsh use, even if they pass inspections. Research shows that wire ropes can wear out quickly under heavy use, and past failures highlight the need for proactive removal. Maintain detailed sling records to guide timely replacements.
