JOURNAL
RECENT IN ENGINEERING
SCIENCE AND TECHNOLOGY

Volume 3 No 3 July 2025

Wire Rope Sling Failure Analysis: Technical Root Causes, Investigation Methodology Critique, and Lessons for Lifting Safety and Organizational Learning

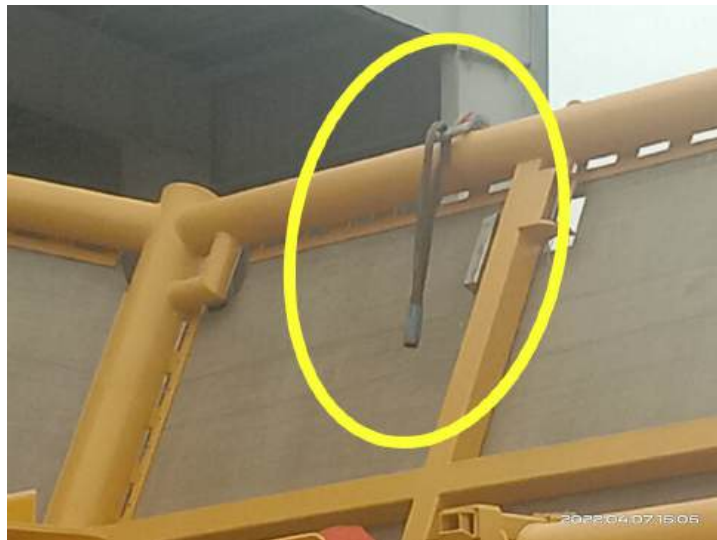
Figure 3. The wire rope sling parted near its end termination – one frayed end remains attached to the panel's padeye (yellow circled).

Figure 3 shows how one frayed end of wire rope sling remains attached to the panel's padeye, and Figure 4 shows the other end recoiled toward the crane hook. Fortunately, all personnel were well outside the exclusion zone, and there were no injuries when the sling snapped and the 19-ton panel dropped. The two broken pieces of sling remained attached at each end – one piece still on the crane's hook and the other still secured to the panel's padeye. The crew immediately stopped all operations and secured the area. Within minutes, they lowered the crane hook to the ground, detached the remaining sling piece, and used a man-lift to recover the sling piece that was still on the panel. The incident was formally reported, and an investigation team was mobilized to examine the failure. The chronological of event is explained in Table 2 in timeline order.

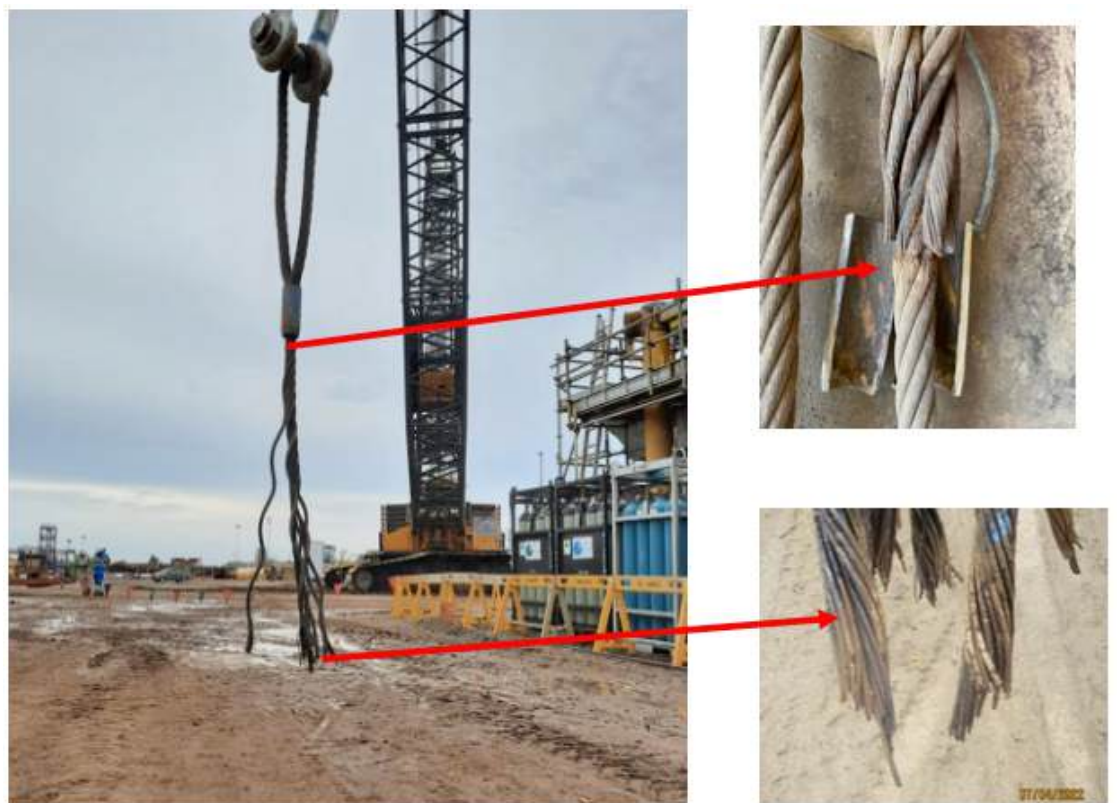
Figure 4. The other end recoiled toward the crane hook. The failure occurred at the sling's ferrule (socket) where the wire rope is swaged, later found to contain corroded wires.

A detailed examination of the failed sling and a review of the operations was conducted by the contractor's investigation team. The wire rope sling was found to have failed at the ferrule (the metal sleeve securing the eye at the sling's end). Close inspection revealed that the wire strands inside the ferrule were severely corroded. The break appeared to originate where the rope enters the ferrule, suggesting a classic hidden corrosion fatigue failure, which significantly reduced the sling's strength. The sling had been in service for 17 years; despite passing a load test three months prior (see Figure 5), it was likely had diminished load capacity due to internal deterioration that went undetected in routine visual inspections.

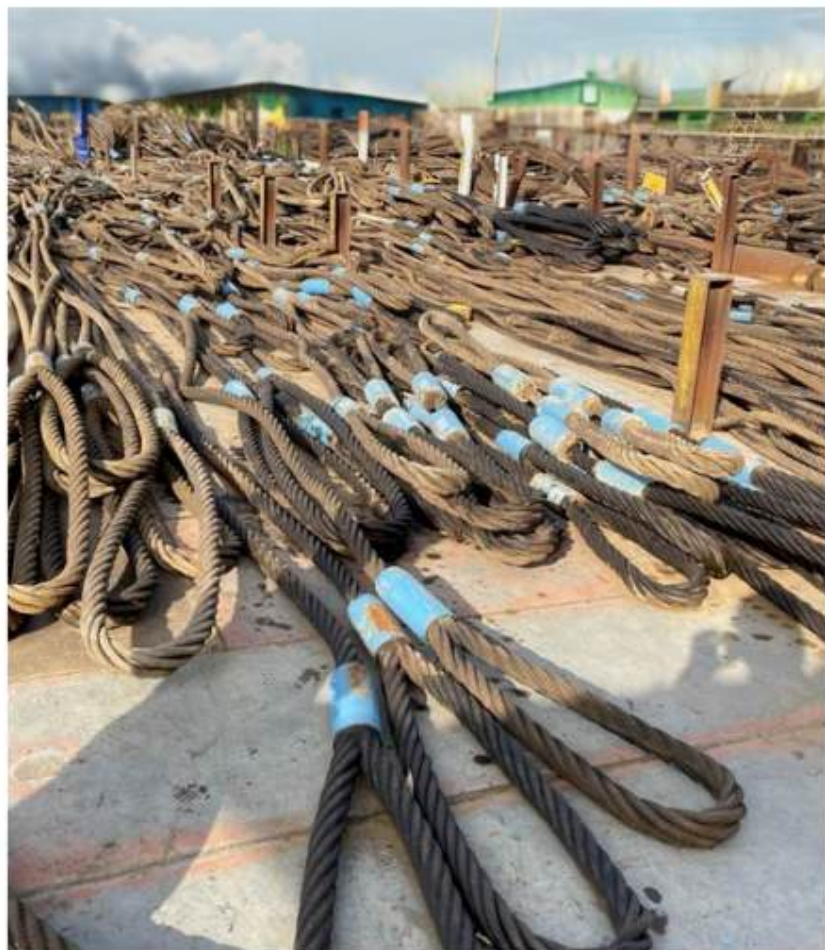
Figure 6. Sling outdoor storage condition

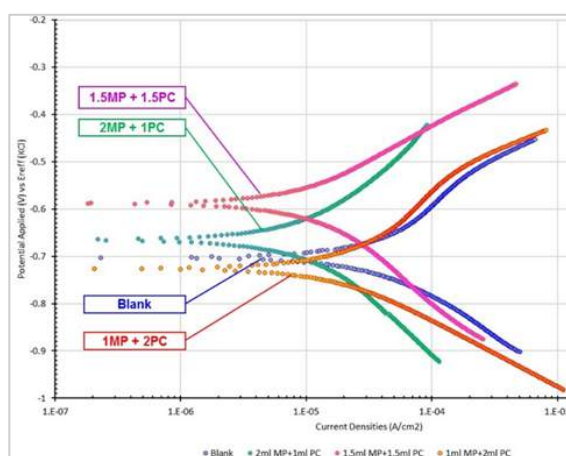
Figure 6. Polarization curve for 3.5% NaCl solution with mixed inhibitor *Myrmecodia pendans* and *Piper crocatum* at various mixed ratio

The results of polarization measurements as shown in Fig. 5-7 and Table 2 indicate that there was an effect of inhibition by natural inhibitors *Myrmecodia pendans* and *Piper*

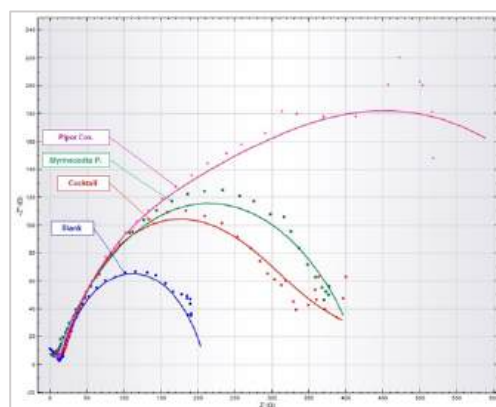
Figure 8. Nyquist plot of 3.5% NaCl solution without inhibitor and with pure cocktail inhibitor and green inhibitor

Electrochemical impedance spectroscopy (EIS) testing was conducted to identify the mechanism of inhibition on Sodium chloride corrosion (sea water corrosion) and surface phenomena that occur at the interface metal / electrolyte due to the effect of inhibitor addition. The EIS test results are displayed in the Nyquist plots on 3.5% NaCl solution without inhibitor addition and with addition of a pure chemical and natural extracts inhibitor as shown in Fig. 8 while the addition of mixed inhibitor of *Myrmecodia pendans* and *Piper crocatum*. Extract on various mixing ratio will generate Nyquist plot as shown in Fig. 9. In addition of mixed cocktail inhibitor and green inhibitor on various mixing ratio will generate Nyquist plot as shown in Fig.10.

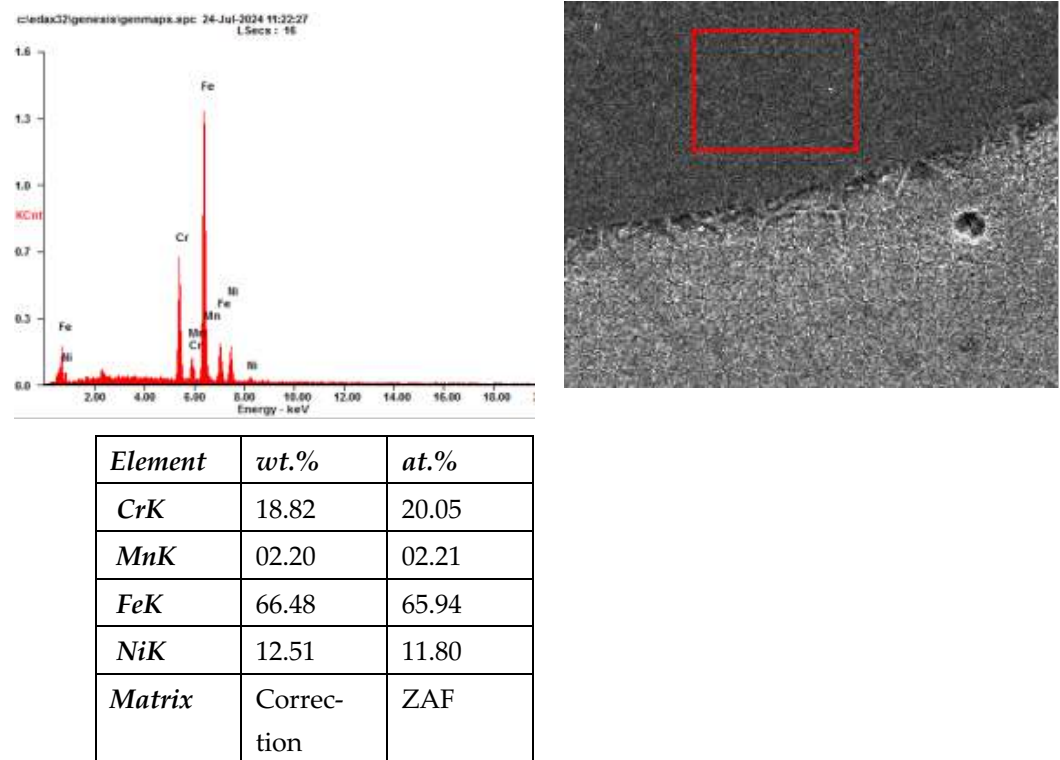
Figure 7 shows the EDS test results for the base metal part of sample B. The base metal part of sample B had higher concentrations of chromium (18.82 wt.%) and nickel (12.51 wt.%) than sample A (16.49 wt.% Cr and 10.64 wt.% Ni). This led to enhanced wear resistance, toughness, and corrosion resistance. The slight increase in Mn in sample B also contributed to the improvement in the mechanical properties. This improvement is evident in the Vickers hardness test results, where the hardness test results of sample B are higher (216 HV) than those of sample A (195 HV). These results show that sample B may outperform sample A for applications requiring high wear resistance and impact toughness. However, the microstructure analysis results show that the interface layer of sample A is superior to that of sample B (it has no defects and is fused).

Figure 7. EDS results for base metal sample B (220/250 A)

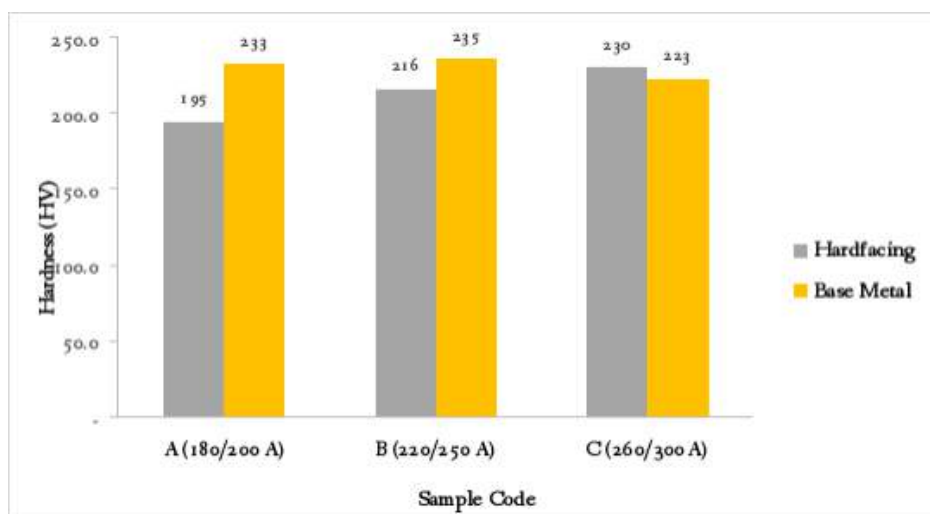
**Figure 11.** Effect of welding parameters on coating hardness

As demonstrated in Tabel 2, sample A exhibited the lowest surface-layer hardness (195 HV). Research has indicated that at lower currents, the layer formed may not undergo sufficient heat or significant dissolution, resulting in a relatively less rigid structure [15]. Sample B exhibited a high-hardness layer (216 HV), this observation signifies that the application of the welding current is adequate for promoting superior heat, resulting in a more refined microstructure. This, in turn, led to the enhancement of wear resistance. As indicated by the higher hardness value (230 HV) of sample C produced an increased hardness layer compared to sample B. The welding process-generated heat energy is also a contributing factor to the enhanced material melting and the strengthened bond between particles within the hardfacing layer. Increased heat input results in the formation of refined microstructure grains. The refined microstructure contains more grain boundaries, which hinder the movement of dislocations, ultimately resulting in increased material hardness [15].

In the case of base metals, the effect of increasing the current on the hardness is not significant. The Vickers test results demonstrated that Sample A (233 HV) yielded the highest base metal hardness, indicating the least softening of the heat-affected zone (HAZ). An increase in the welding current resulted in a slight rise in the base metal hardness of Sample B, as indicated by an increase of 235 HV. This phenomenon can be attributed to the broader heat input exerting its influence on the HAZ. The increased heat resulted in a greater degree of austenitization of the base metal. During the rapid cooling process, when the cooling rate remains high, martensite formation is enhanced. In sample C, an increase in the welding current decreased the base metal hardness (230 HV). This indicates that an increase in the heat input can reduce the cooling efficiency, particularly in cases where the thermal mass is substantial. Slow cooling will form ferrite and pearlite phases, reducing the hardness.

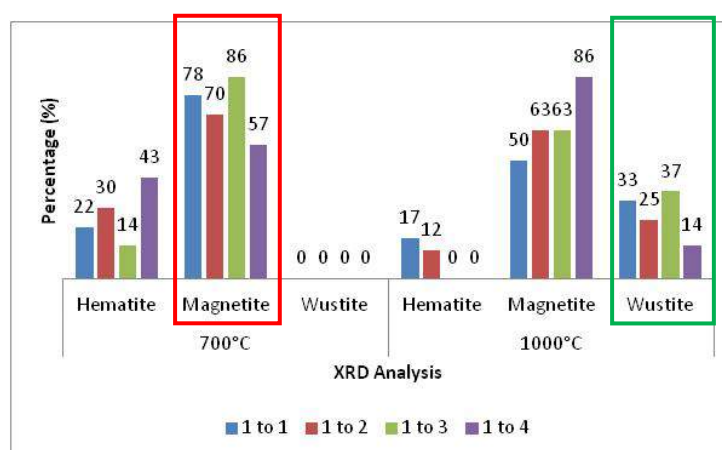
Figure 4. The percentage values for peak intensity in reduction process at 700 °C and 1000 °C

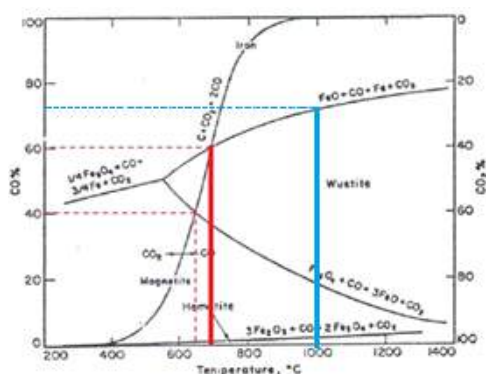
Figure 5. The Glaessner – Boudouard Diagram [22]

Moreover, this case has shown that wustite (FeO) is not formed at 700°C due to the instability of carbon monoxide formation. Higher temperature facilitates metallic iron formation, as shown at 1000°C and supported by the Ellingham Diagram.

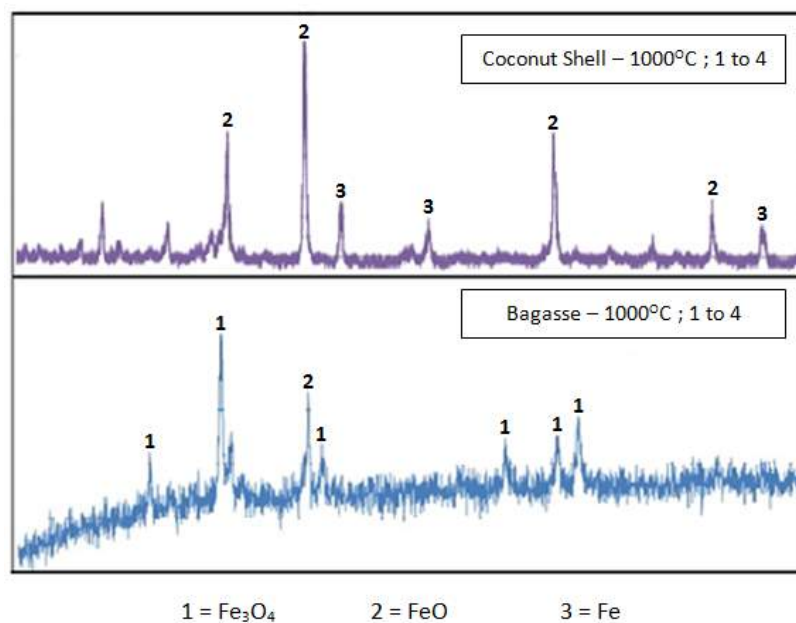
Figure 7. XRD analysis for reduction process with different reductors
