Vol. 4 No. 3 (2026)

# Recent in Engineering Science and Technology (RiESTech)

Vol. 4 No. 3, July 2026

# Risk-Based Integrity Evaluation of Hydrocarbon and Utility Piping Systems Using Corrosion Rate, Remaining Life, and Inspection Data: A Quantitative Case Study

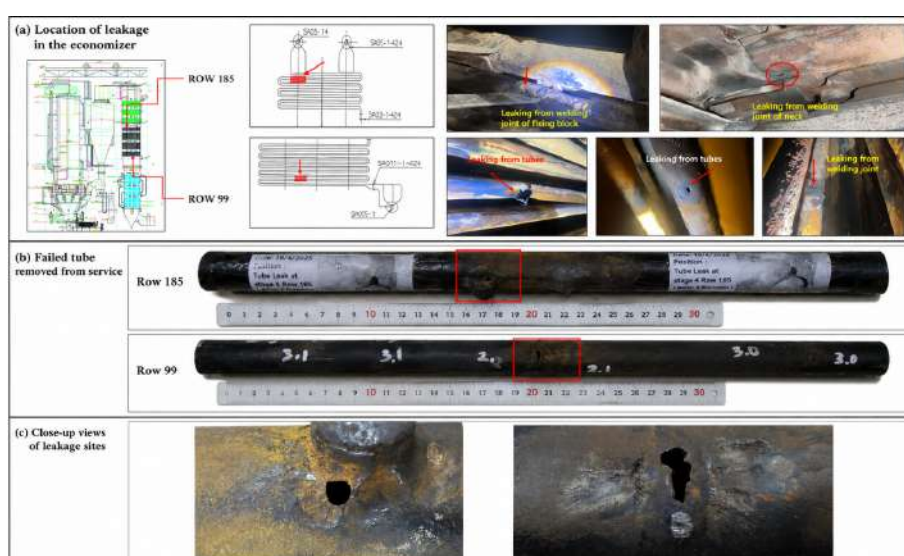
**Figure 1.** Field inspection and macroscopic appearance of failed economizer tubes.

- (a) Leakage locations identified in Rows 99 and 185 during boiler shutdown inspection.  
 (b) Failed tubes removed from service showing the position of leakage.

The failed tubes removed from service are presented in Figure 2(b), while close-up views of the perforated regions are shown in Figure 2(c). Leakage was concentrated near circumferential and stopper-weld locations where wall thinning and corrosion products were evident. In contrast, adjacent tube sections remained comparatively intact. The confinement of damage to the welded regions suggests that local geometric and environmental factors played a more significant role than generalized corrosion across the economizer tubing system. These observations were subsequently examined through thickness measurements and microstructural characterization to determine the mechanism responsible for leakage formation.

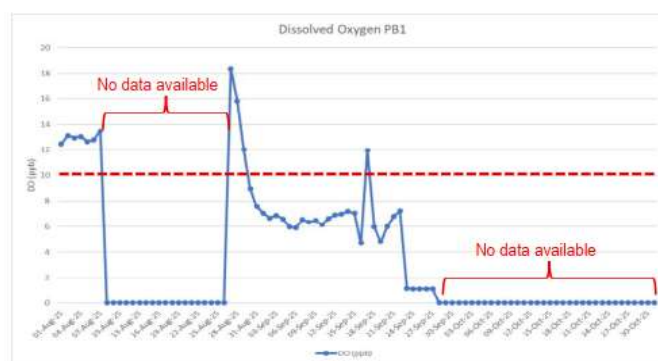
**Figure 5.** Record of Dissolved Oxygen (DO) at PB1

DO monitoring records from August to October 2025 are presented in Figure 5. The available measurements indicate dissolved oxygen (DO) concentrations ranging from approximately 1 to 19 ppb during the monitoring period. However, the records contain two intervals where no monitoring data were available, limiting the continuity of the dataset. Consequently, the available data are insufficient to establish a direct relationship between dissolved oxygen concentration and the observed corrosion behavior.

Although the available dissolved oxygen (DO) records were incomplete, the observed fluctuations, together with the metallographic and SEM-EDS findings, suggest that unstable oxygen conditions may have contributed to the corrosion process.

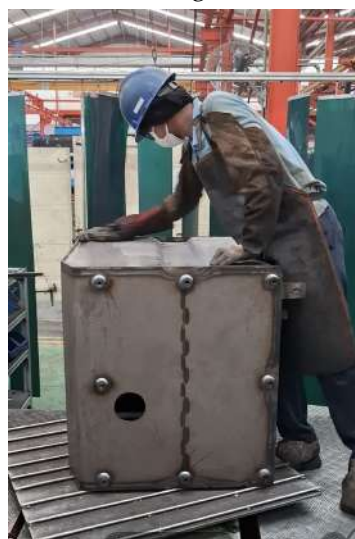
The study began with direct observation of the operator's work activities to identify postures that pose a risk of MSDs. The observation covered lifting, moving, reaching, and rotating the heavy workpiece. Photo and video documentation were then used to obtain body-posture angles. The posture shown in Figure 2 was selected because it represents the main non-neutral positions found during the task and was used for the subsequent angle measurement and RULA–REBA scoring.

**Figure 2.** Representative initial posture used for angle measurement and ergonomic assessment

The observation results showed that the operator performed heavy material handling and workpiece repositioning manually. The representative posture in Figure 2 involved trunk and neck flexion, upper-arm elevation, wrist deviation, and unstable lower-limb support. These conditions indicate a non-neutral posture that may increase musculoskeletal loading during the task [1,9,14].

The complaint locations are consistent with the body segments loaded in the posture shown in Figure 2. Because the NBM involved one operator, the findings are interpreted as a description of the observed task and not as a percentage of workers with complaints.
