Design and Construction of Magnetic Support Construction Separator on Track V 33 BC-5 at Greenzone 2

Abstract: The process of shredding and sorting waste in the Pre Processing method is one of PT Solusi Bangun Indonesia's contributions in overcoming waste and pollution problems. The waste will be shredded into certain sizes and put into the cement kiln. The processing place is called a green zone. In this process, sometimes the material transport contains impurities in the form of metal and the like. This distribution has the potential to cause foreign material to be carried because there is no sorting of waste content. Belt conveyors and dynamic disc screens are often damaged by the metal material. This problem can be overcome with a magnetic separator to separate foreign metals from waste that is channeled using a belt conveyor. The magnetic separator provides protection for the dynamic disc screen and conveyor operating process from foreign material so that the potential for wear on the dynamic disc screen and torn belt conveyor can be avoided. The installation of the magnetic separator position uses a construction based on the optimal position. This study discusses the design

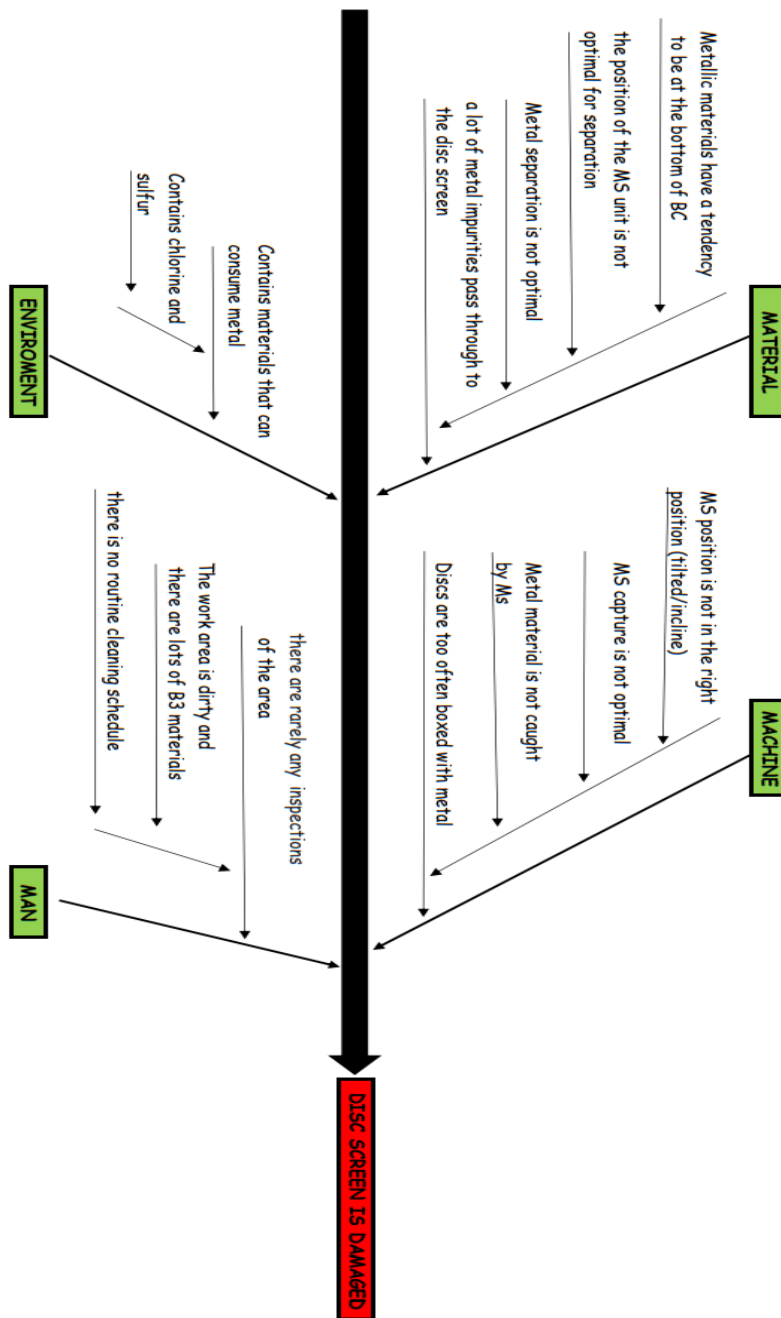
Figure 3. Root Cause Failure Analysis

Based on Figure 3, it can be divided and described from each existing indicator such as machine, material, and environment.

Based on the analysis of the fishbone diagram from the machine side. Disc material often hits metal material due to suboptimal metal material capture. This is because the position of the MS unit is on the incline conveyor so that the Belt on the MS unit is often tilted and the material is not lifted optimally.

Based on the fishbone diagram, it can be concluded that AF material contains the most Sulfur and Chlorine. So it can easily corrode uncoated metal materials. Figure 5 shows the sulfur and chlorine content contained in the material to be processed in greenzone 2.

Based on the analysis using the fishbone diagram, the biggest influence on disc screen damage is the amount of metal material stuck in the disc screen.

In addition, based on direct conditions in the field, the position of the old Magnetic separator in the inclined position also affects the capture of metal materials. This is because the metal material is covered by clumps of garbage.

Based on field observations, it was found that there was no cleaning schedule or clean up schedule in the disc screen area routinely. This happened because of the large amount of garbage covering the area and the pungent odor and B3 materials that could be harmful to the skin so that special PPE was needed during cleaning.

However, after the installation of the new MS unit with the design and calculation of the method. In the period from February 2024 to July 27, 2024, there have been no reports or repairs caused by magnetic separation problems. So that the design, planning, and construction methods can be said to save maintenance costs on greenzone 2 operations.
